SPE-184868-MS

A Causation Investigation for Observed Casing Failures Occurring During Fracturing Operations

N. J. Adams, Neal Adams Services; R. F. Mitchell, Well Complete; A. W. Eustes and J. H. Sampaio, Colorado School of Mines; A. O. Antonio, Neal Adams Services

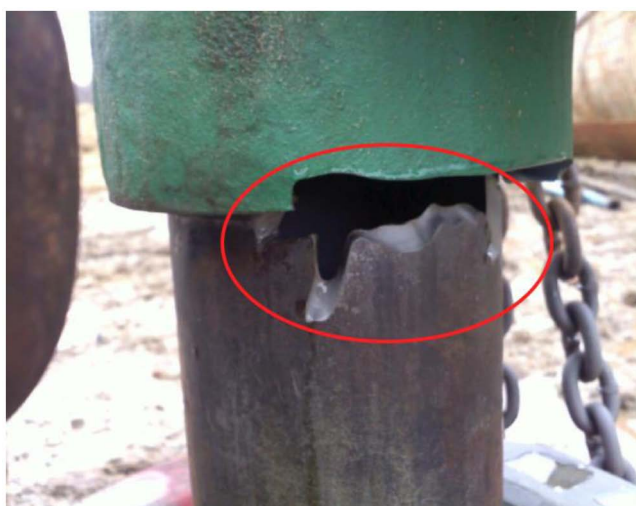
Figure 1—A fatigue crack at the wellhead-casing interface resulted in a blowout. The fatigue was vibration-induced.

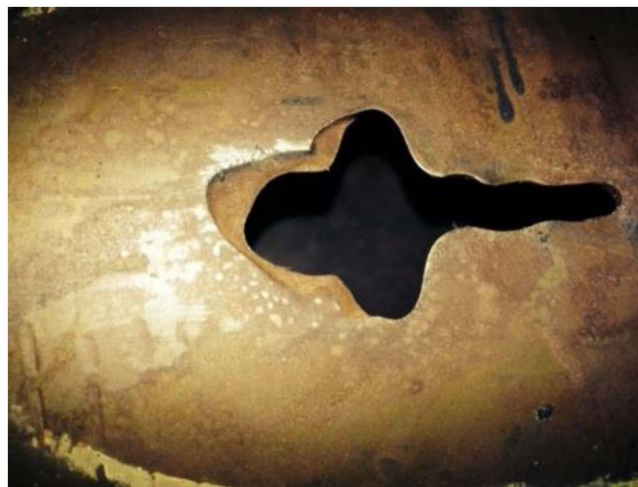
Two case history failures were caused by erosion in similar circumstances. ERW pipe was being used. The seam on the internal weld line was attacked by the proppant (Fig. 3). The erosion-generated hole grew until it had penetrated the tube's outer wall. The failure indicator was lower-than-anticipated pump pressures. In both cases, the operator successfully identified the anomaly prior to complete pipe parting.

Figure 3—Internal erosion on the weld line of ERW pipe penetrated the pipe's wall thickness. Erosion can initiate at physical anomalies such as grind marks. (Case History No. 3)

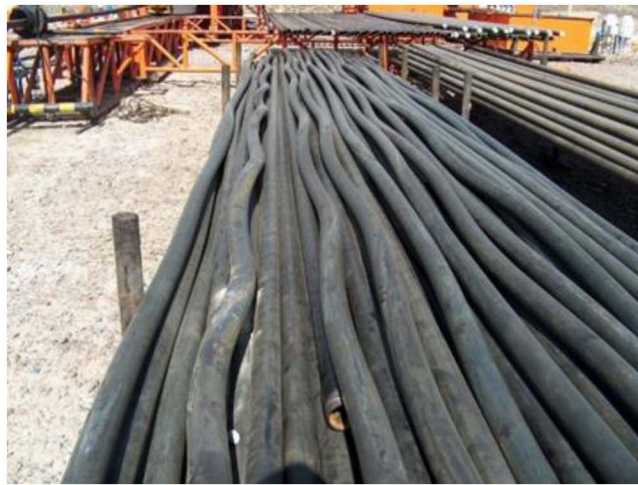
Figure 5—A high pressured, fracture treatment allowed the pipe to buckle. A permanent deformation of the pipe occurs when the buckling-induced stresses exceeds the pipe's yield strength. (Photograph courtesy of Dr. Robert Mitchell.)

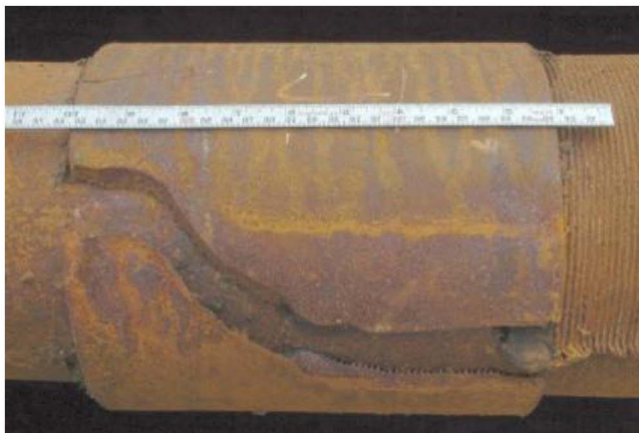
Fatigue. Fatigue in the coupling area appears to be associated with most casing failures even though new casing was run in the wells (Fig. 8). Loads or deformations which will not cause fracture in a single application can result in fracture when applied repeatedly. Fracture may occur after a few cycles or after millions of cycles. This process of fracture under repeated loading is called *fatigue*. The mechanisms of

Figure 8—The crack observed in this photograph resulted from coupling fatigue. (Case History No. 7)

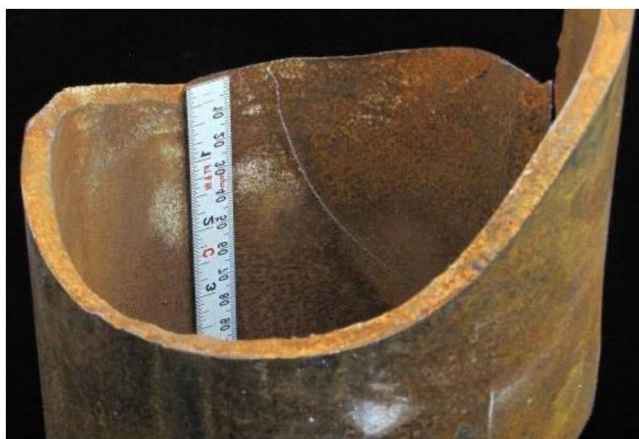
Brittle Failures. The laboratory test reports often noted brittleness when discussing failures (Fig. 9). Resistance to brittle failure is called *toughness*. The toughness of a material is its ability to absorb energy and resist brittle fracture. Brittle fracture is catastrophic and can be manifested at stresses below the yield strength of the material. Brittle materials have low toughness because they experience only small plastic deformations before fracture. Generally, toughness decreases with increasing yield strength. Temperature can have a significant impact on the toughness of carbon and low-alloy steels. Toughness is usually measured using the Charpy impact test at a specified temperature. Elongation requirements are also a measure of ductility and are used to ensure adequate toughness. [Texter \(1955\)](#) and [Payne \(1993\)](#) identified brittle failures during their investigations.

Figure 9—A visual examination of the failed casing showed a brittle fracture. Lab testing indicated that the failed specimen's yield strength exceeded the API's acceptable ranges. The pipe was improperly tempered during the manufacturing, as shown by harness testing. (Case History No. 10)

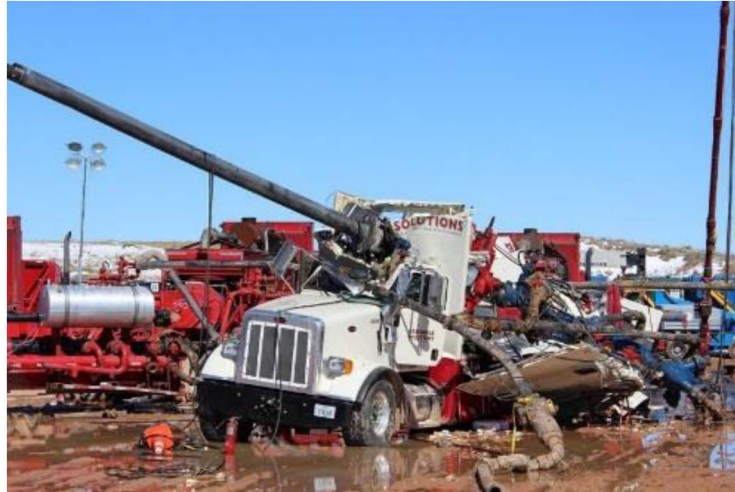
Figure 10—A crack at the wellhead-casing interface caused this failure (see Table 2, number 4). The wellhead and short sections of surface and production casing were ejected. The projectile speared the truck's cabin. (The driver was not in the truck.)

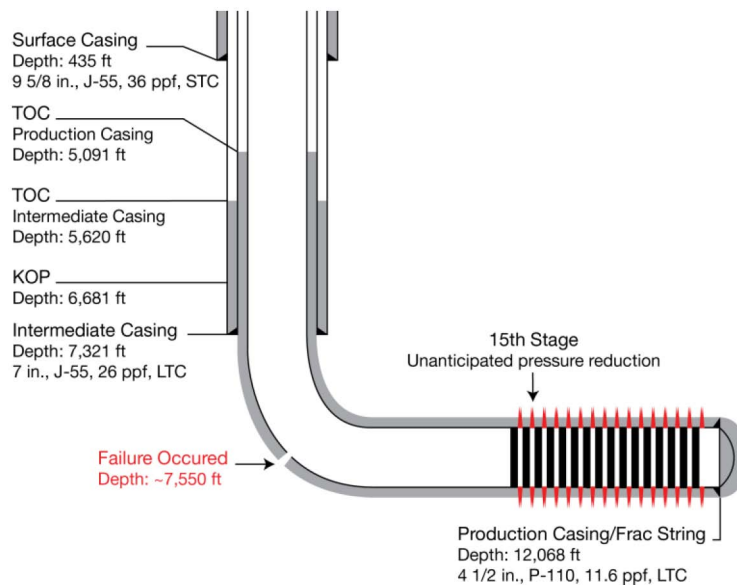
Figure A-1—A failure occurred at ~7,550 ft while pumping the 15th stage. The operator successfully recovered the wellbore and produced the well.

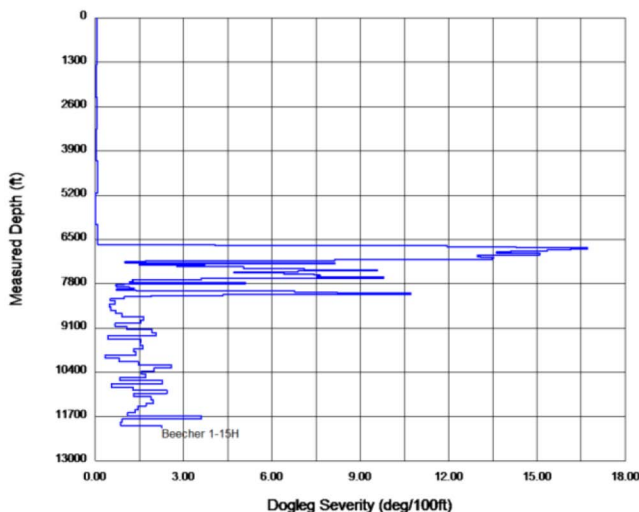
Drilling operations create dog-legs in the wellbore. Survey data was used to determine the bending severity from the dog-legs (Fig. A-2). The magnitudes of these dog-legs were characteristic of other case histories involving build sections. Although the severities are initially alarming, preliminary conclusions from this investigation indicates that dog-legs may not play a significant role in casing failures.

Figure A-2—Dog-legs in the build section exceeded 16.5 degrees. Other case histories had dog-legs greater than 30-35 degrees.

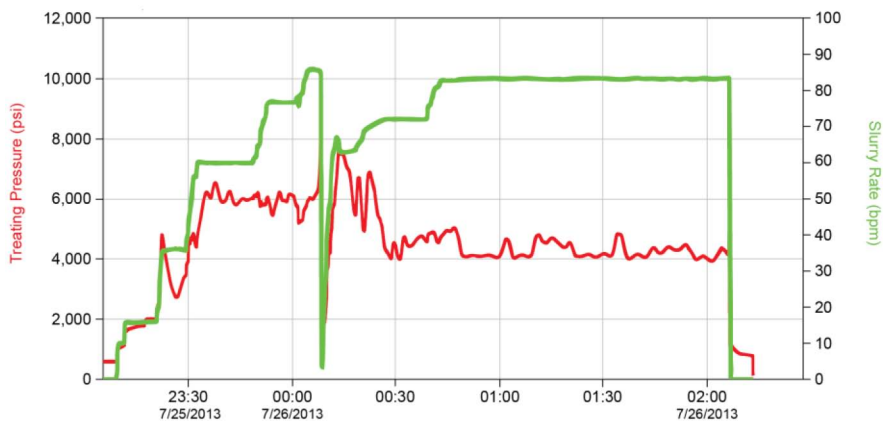
Fig. A-3 shows the surface treating (pump) pressures and slurry rates for the 15th stage in which the failure is believed to have occurred. Pumping operations started at ~2309 hours with a maximum rate of ~86.5 bbl/min and pressure of ~8,550 psi at 0005 hours. It appears the pumps were equipped with an overpressure (auto-stop) feature which was set at 8,500 psi and triggered when surface pressures reached ~8,550 psi. After a short shut down period of 77 seconds, operations continued with a pump rate of ~84 bbl/min accompanied by pump pressure fluctuations.

Figure A-3—The fracture treatment report for the 15th stage recorded pump rates and pressures. The failure occurred shortly after midnight. Pressures after the failure were substantially lower than previously estimated.

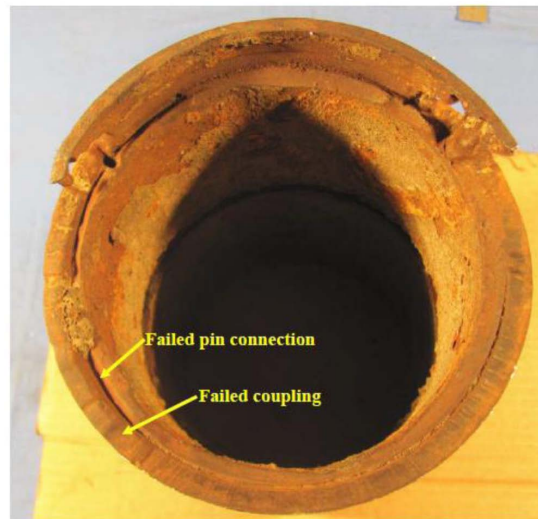
3. Washing damage was present on the fracture surface of the pin connection. A fatigue crack (or multiple cracks) likely propagated through the wall thickness of the pin, created a fluid path directly from the string bore to the wellbore annulus. Subsequent erosion of the pin created characteristic "washing" in the pin.
4. The remaining portion of the fracture was oriented 45° to the casing longitudinal axis, which is typical of ductile overload. The fatigue cracks propagated and reduced the cross-sectional area. When the applied load finally exceeded the load carrying capacity of the remaining cross-sectional area after erosion, the connection failed due to ductile overload.

The characteristics observed in this incident are similar to other observed failures. A fatigue crack is observed in the last engaged thread (first exposed thread). Crack propagation leads to a failure. Cracks have been observed in the field and mill ends of the coupling. The failure appears to have occurred without warning signs.

Figure A-4—The failure resulted from a fatigue crack in the last engaged thread (first observed thread). The photograph shows characteristics shared with other failures.

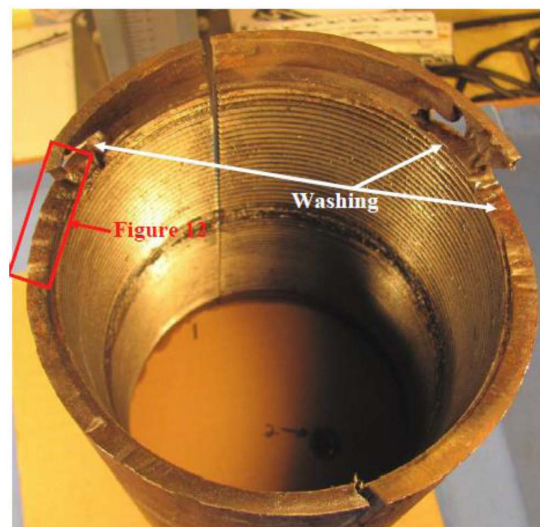
Figure A-5—Erosion occurred as the crack propagated around the casing's circumference. Erosion did not cause the failure.
