SPE-184868-MS

A Causation Investigation for Observed Casing Failures Occurring During Fracturing Operations

N. J. Adams, Neal Adams Services; R. F. Mitchell, Well Complete; A. W. Eustes and J. H. Sampaio, Colorado School of Mines; A. O. Antonio, Neal Adams Services

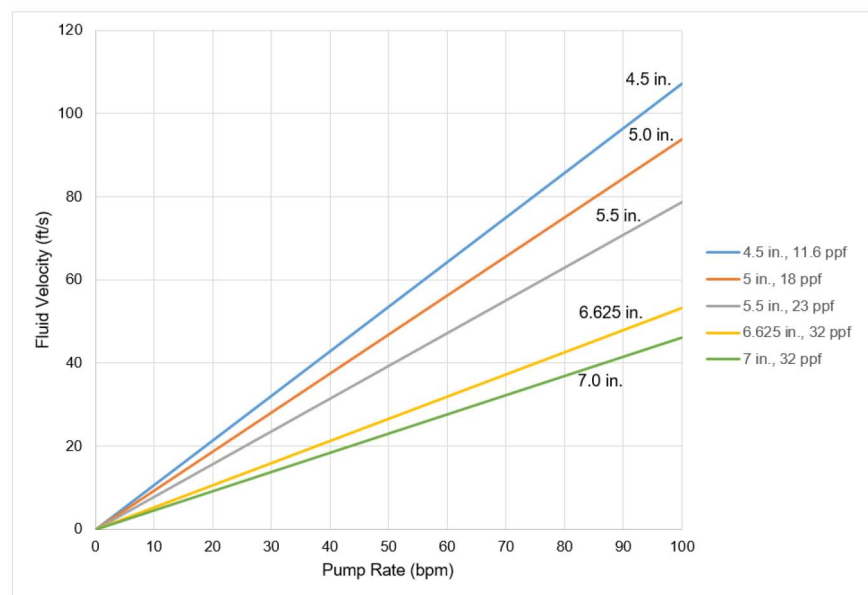
Figure 2—Fluid velocities associated with various pump rates and casing sizes commonly used for fracturing operations. Velocities are shown in ft/sec (ft/s). A pump rate of 86.5 bbl/min (bpm) (Fig A-3) resulted in fluid velocities greater than 90 ft/sec.

Erosion. An undesired byproduct from fracturing operations is erosion. Fracturing fluids containing proppants, usually some type and size of sand, are pumped at high rates and fluid velocities. As previously shown in Fig. 2, velocities of 70-100 ft/sec are the expected norms. Factors affecting erosion include the roughness of the inner tube wall, hardness and angularity of the proppant, brittle vs ductile pipe, fluid velocity, straightness of the tube and many others. The complexities of the erosion process under stimulation conditions precluded further investigation at this time.

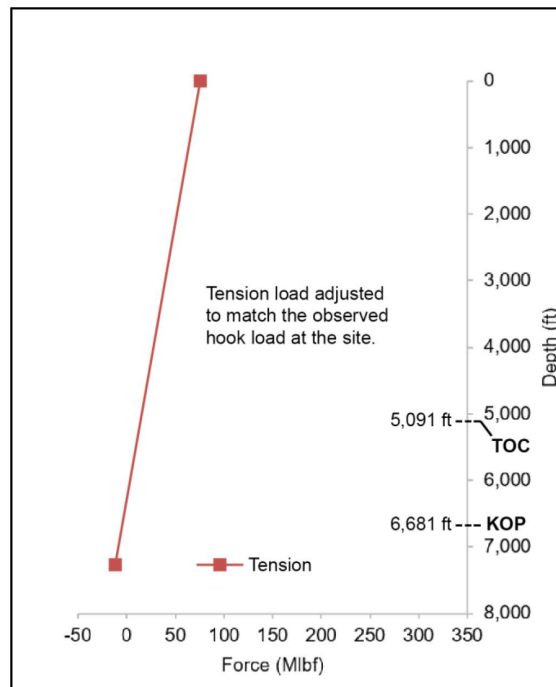
As part of this investigation, a model was developed to evaluate stress increases associated with Clark's suggested considerations. Case History No. 1 (Appendix A) was used to describe modeling results. An adjustment was made to the calculated hook load so it would match the recorded hook load at the site. The calculated hook load was shifted to the observed value. The result was that a negative tension (compression) was observed at the bottom of the casing below 6,681 ft in the build section (Fig. 11a). The accuracy associated with this adjustment can't be tested but is believed to be within an acceptable range for the purposes of these calculations.

Figure 11a—Tension load adjusted to match the observed hook load.

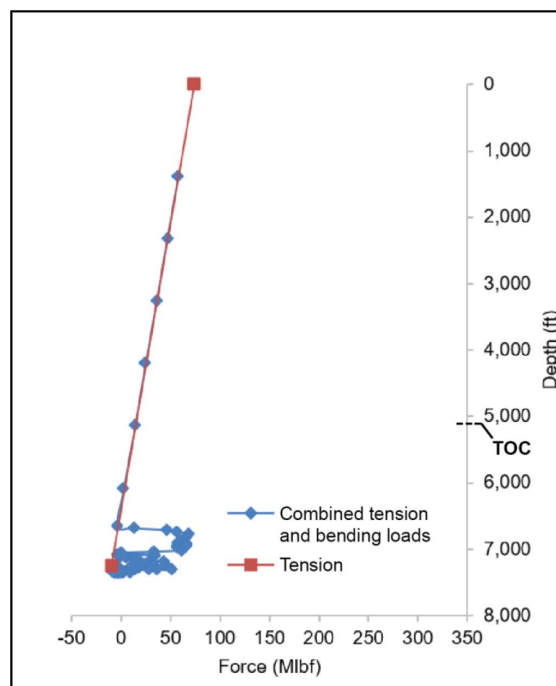
The bending stresses were calculated with Lubinski's equation. Fig. A-2 shows the dog-legs used for the calculations. The results were added to the initial tension loads (Fig. 11b). As previously indicated, bending stresses typically don't have a significant impact when evaluating the cumulative loads. The combined loads from tension and bending at the bottom of the string are lower than combined loads at the surface.

Figure 11b—Combined tension and bending loads.

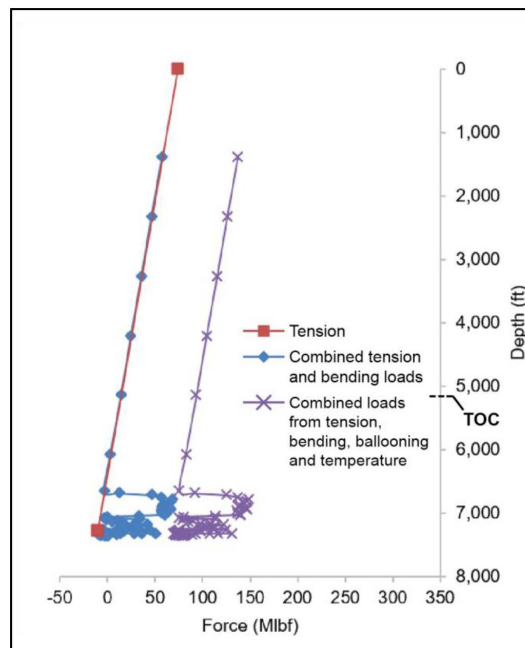
prevents pipe movement, additional forces are applied. The combined loads from the initial pipe tension, bending, ballooning and temperature decreases are shown in Fig. 11c. Temperature typically provides the largest stress changes followed by pressure (ballooning).

Figure 11c—Combined loads from tenion, bending, ballooning and temperature.

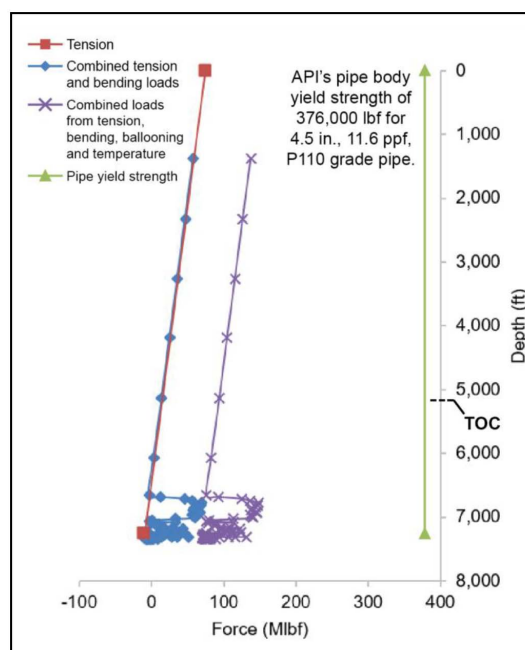
To complete this evaluation, the pipe body's yield strength of 367,000 lbf was compared to the applied loads (Fig. 11d). The pipe's yield strength exceeded the applied load by a factor of 2. This observation is consistent with the modeling results from the other case histories.

Figure 11d—A comparison of API's pipe body yield strength of 367,000 lbf for 4.5 in., 11.6 ppf, P110 grade pipe and combined loading conditions.

A disclaimer for the API pipe body yield strength of 367,000 lbf is warranted. The subject pipe was manufactured to provide a collapse rating greater than the API's rating. Mills use proprietary methods when manufacturing HCP pipe. As such, the API's yield strength may not apply to HCP pipe. Nonetheless, P110 HCP pipe is likely to have a yield strength that exceeds the combined loading.
